# Manhole Inspection Summary

Manhole # S47CC\_062MH

Insp Date: **2/7/08 9:48 AM**

**Location** Address: **COLLINGTON-DUNCAN**

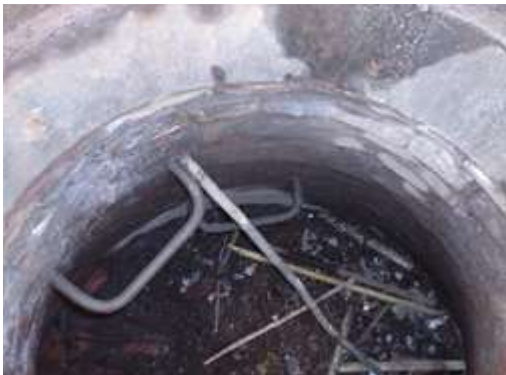
Defect 2

☒ **Leaks**

Frame Leaks

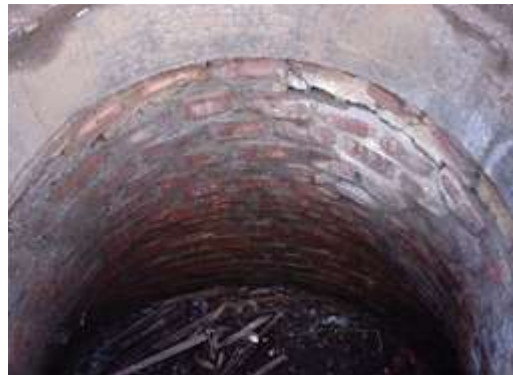
Defect 1

Condition: ☐ Sound ☒ **Cracked** ☐ Root Intrusion ☐ Loose Brick ☐ Deteriorated

Infiltration: ☐ None ☐ Joint ☒ **Cracks** ☐ Mortar ☐ Roots ☒ **Wall**

Cracked Chimney

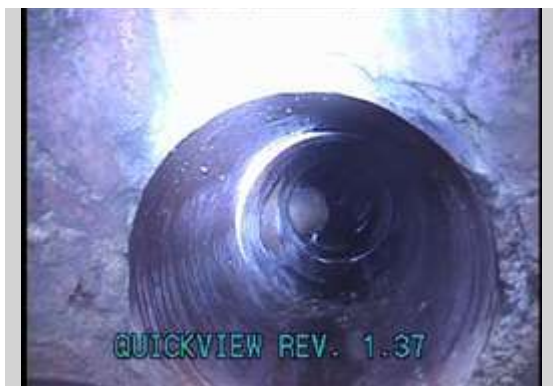
12 O'Clock Outflow

10 in. Circular Gravity Sewer  
Pipe Out @ 12 O'Clock

Infiltration: **None** Pipe Seal Cond: **Sound**
